SECTION 504 COMPLIANCE REVIEW REPORT

Denver Museum of Nature and Science

Denver, Colorado

March 2011

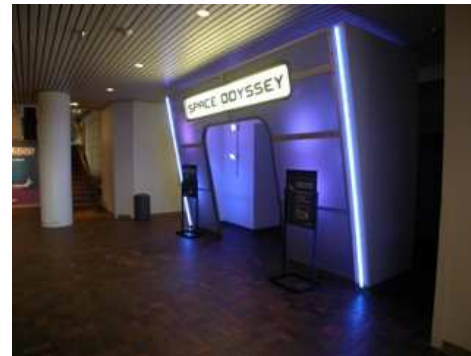
Figure 1-- Slanted Wall Entry to Space Odyssey Exhibit

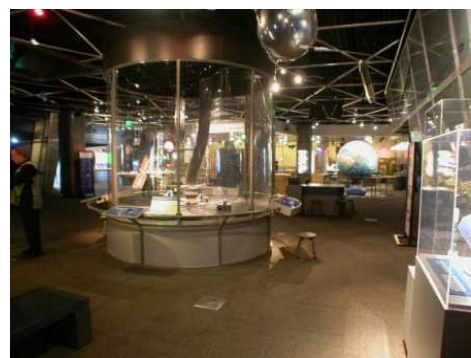
Figure 2 - Protruding Plaques and Controls

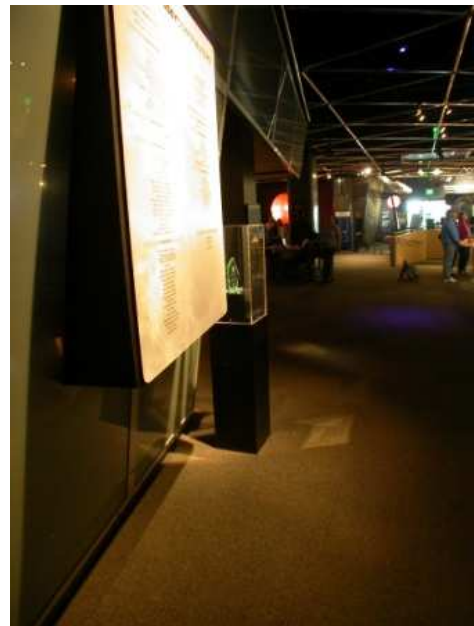
- e. The large white plaque listing "Space Odyssey Contributors" and positioned to the left of the little theater area is mounted on a slanted wall such that the bottom projects more than 4" into the main approach route to the exhibits with its leading edge above 27" (UFAS 4.4). See Figure 3

Figure 3 -- Protruding Donor Plaque

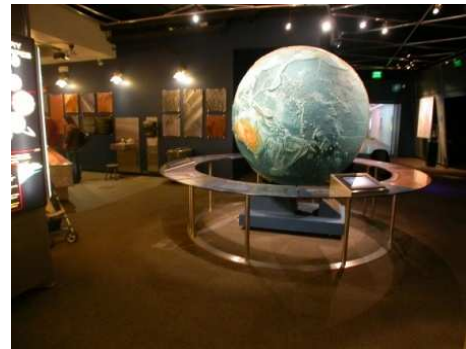
Figure 4 - Information Ring Not Cane Detectable

- f. The circular information element surrounding the large globe showing the topography of the seas has its leading edge at 34" and no cane detectable barriers (UFAS 4.4). See Figure 4

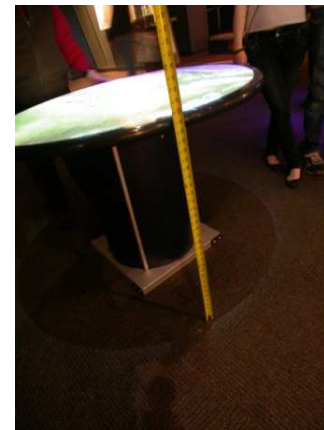
Figure 5 - Display Top Not Cane Detectable

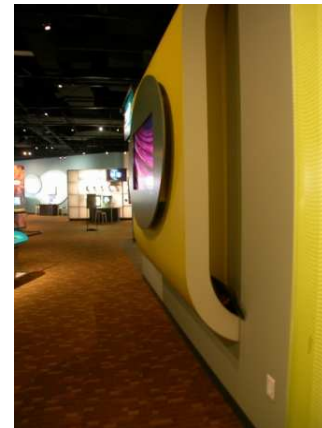
Figure 6 - Protruding Monitor

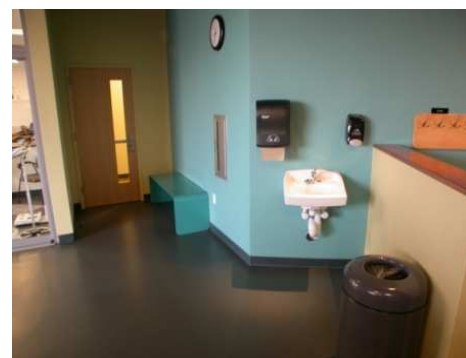
- f. The wall mounted lavatory in the "Biology Base Camp" area projects further than 4" into the circulation route above 27" without a wing-wall or bollard on the left side to establish an alcove into which this element may appropriately be located (See Figure 7). The addition of a wing-wall or bollard on the left side of the lavatory to create a compliant alcove will necessitate the relocation of the wall mounted paper towel dispenser so it is in an alternate accessible location nearby with adequate clear floor space.

Figure 7 - Lavatory and Bench Issues

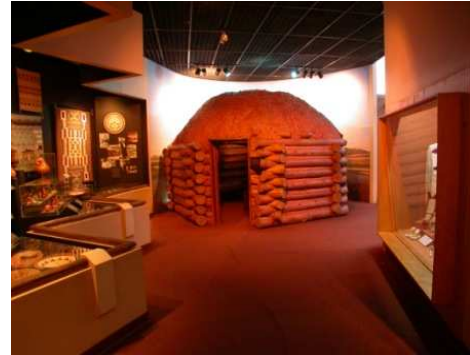
Figure 8 - Low Doorway in Hogan

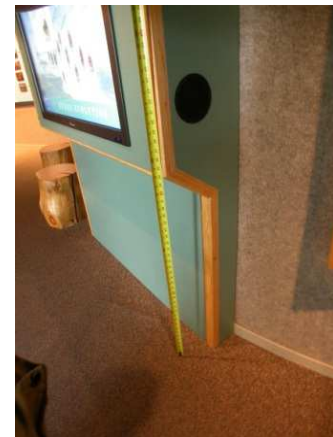
a. The "Explore Human Evolution" monitor display near the exit of this exhibit on the lower level. See Figure 9

Figure 9 - Protruding Monitor

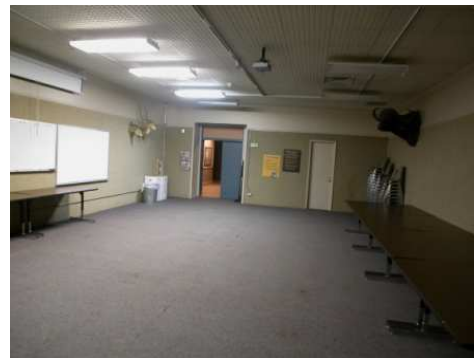
Figure 10 - Narrow Entry Doors

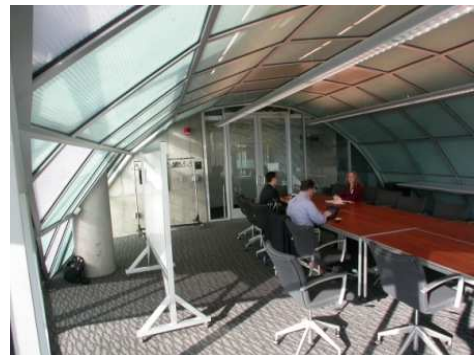
Figure 11 - Low Head Height Issues

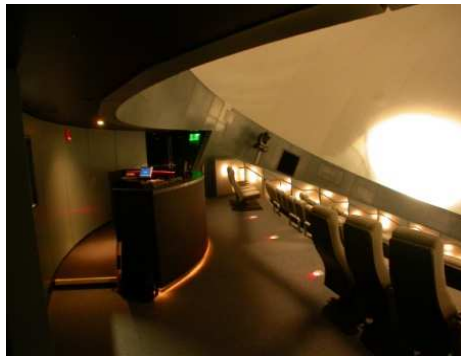
The tape-stanchions used here and elsewhere in the Museum are not cane detectable because the underside of the tape (at 37") is higher than the maximum 27" cane detectable height (UFAS 4.4) and should be

Figure 16 - Planetarium Wheelchair Seating

modified to include an additional tape barrier at or below 27" (See Figure 16). While the sound and light control booth behind the wheelchair seating is positioned such that there is not a minimum 36" accessible route (UFAS 4.33.3) behind the central wheelchair

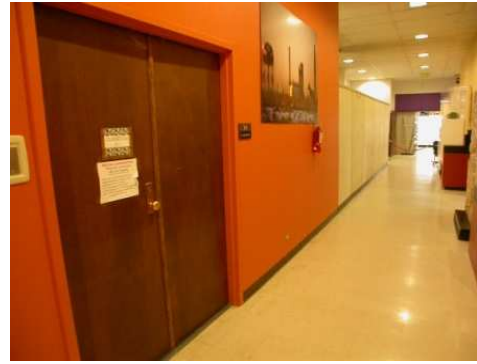
5. **Level 3 - Classrooms 303, 303 & 311 near Bailey Library.** Each of the classroom doors into these spaces used by visiting students has inaccessible knob style door hardware and less than the minimum 18" latch side, pull side maneuvering space required for independent wheelchair use (UFAS 4.13.9; 4,13.6). At classroom 311, the pair of doors leading into this classroom provides less (at only 27") than the minimum 32" clear passage width for one leaf (UFAS 4.13.5). See Figure 12

Figure 12 - Knob Hardware on Narrow Doors

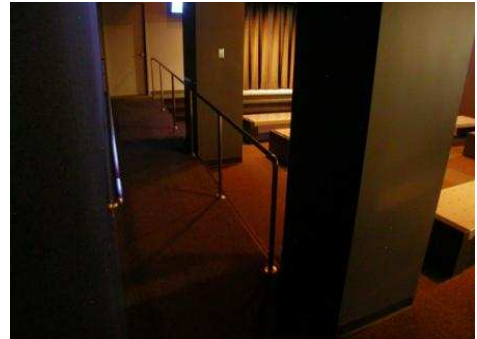
Figure 13 - Inaccessible Route to Stage

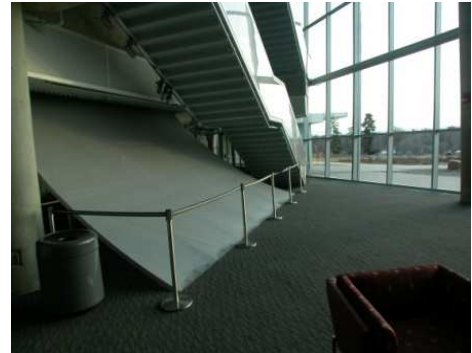
- a. The tape stanchions along the sides of the curved sculptural metal panels and the monumental stair are not cane detectable; See Figure 17
- b. The wall mounted stainless steel fire extinguisher cabinet to the right of the Gates Planetarium entrance; See Figure 18
- c. The angled end of the monumental stair guardrail at the bottom of the steps; See Figure 19
- d. The stainless steel guardrails under and behind the curved sculptural metal panels in the lobby area opposite the doorway into the Space Odyssey exhibit space. See Figure 20

Figure 17 Tape Barriers Not Cane Detectable

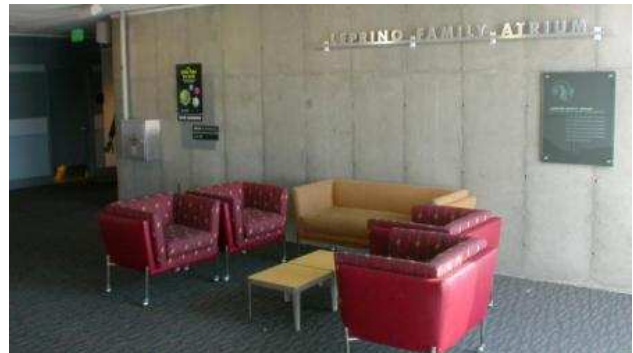
Figure 19 - Protruding Fire Extinguisher Box on Wall

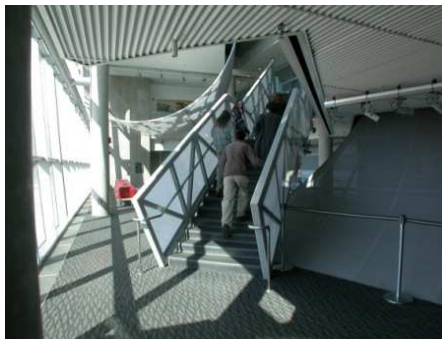
Figure 20 - Protruding Stair Railings

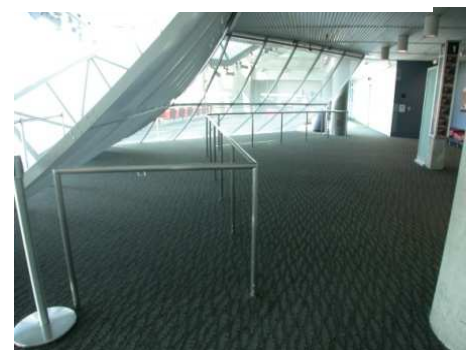
Figure 18 - Unprotected Guardrail

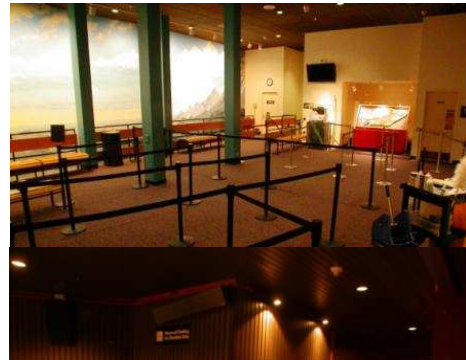
The main interior entrance to the IMAX during business hours is on Level 2 just off the Main Circulation Core balcony area and that door leads into a large waiting room from which ushers lead visitors without disabilities down steps to the IMAX auditorium. In the entrance queuing areas on each side of this main interior entrance are established by tape stanchions which are not cane detectable to blind and visually impaired visitors (UFAS 4.4). See Figure 22

Figure 22 - IMAX Queuing Area on Level 2

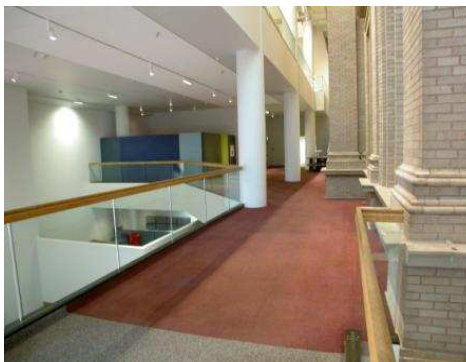
Figure 24 - Protruding Trim at South Atrium

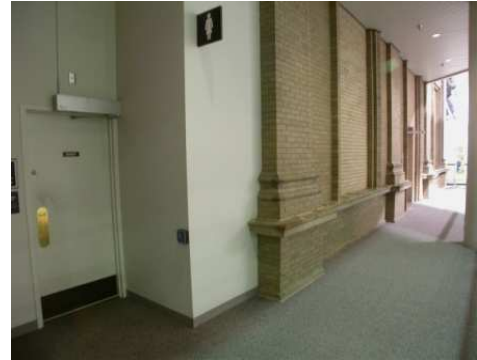
Figure 25 - Protruding Trim at North Atrium

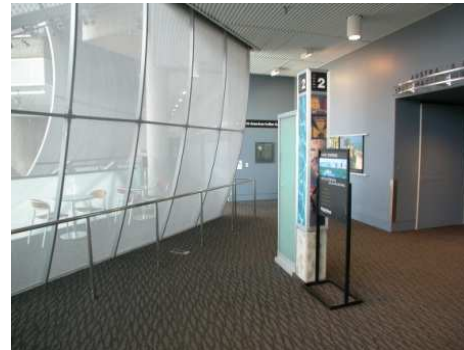
Figure 26 - Railing Not Cane Detectable on Level 2

- a. The stainless steel guardrails under and behind the curved sculptural metal panels in the lobby area opposite the doorway into the Australia exhibit space; See Figure 26

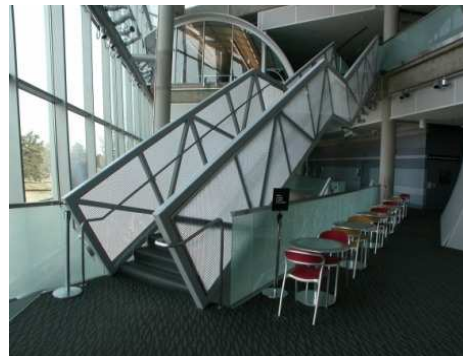
Figure 27 - Stair Rail is Protruding Barrier

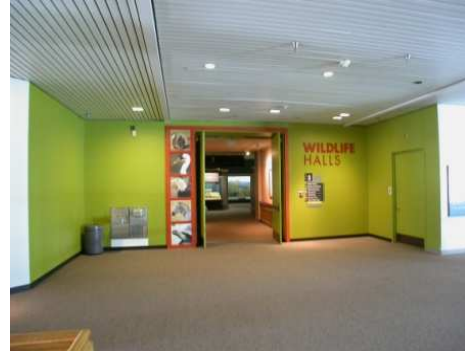
Figure 28 - Drinking Fountains Not Cane Detectable

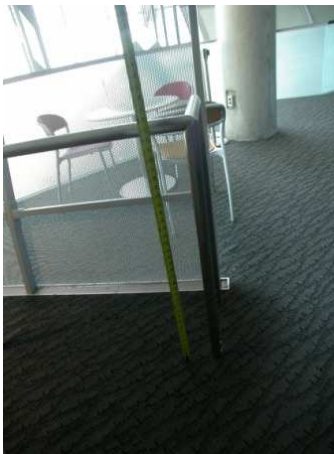
Figure 29 - Guardrail Not Cane Detectable on Level 3

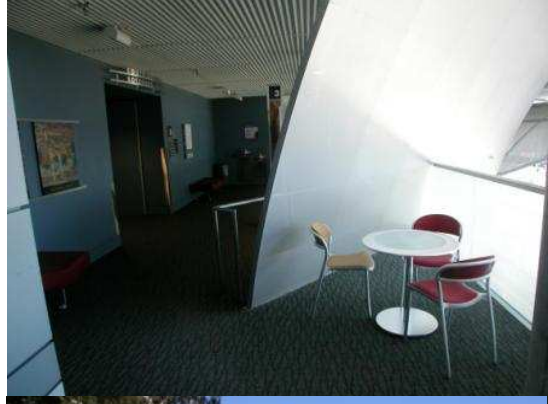
Figure 30 - Panel & Railing on Level 3 are not Cane Detectable

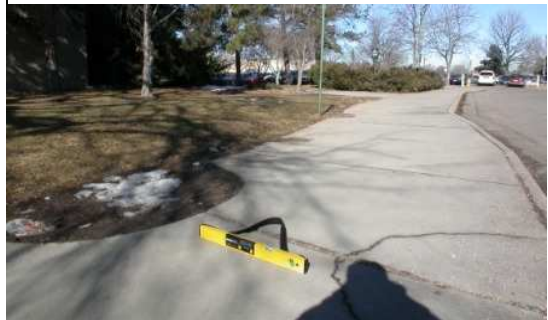
Figure 31 - Steep (4.9%) Cross Slope on Approach Walk new IMAX "After Hours" Entrance

along Colorado Blvd. and the "After-Hours" Entrance at the IMAX includes steep (up to 4.9%) cross slopes along the sidewalk at the northeast corner of the building at an abandoned tree grate - this inaccessible section of the sidewalk must be replaced to achieve an accessible route per UFAS 4.3 & 4.1.1(1). See Figure 31. At least one accessible route to each of the main public entrances from the main accessible surface parking located in front of the north facade (east side) and the designated accessible surface parking immediately in front of the main entrance plaza is substantially compliant with UFAS provisions. When the proposed addition to the south side of the Museum is constructed, it would improve the safety of these pedestrian approach routes if new accessible approach walks were to link each of the access aisles in this accessible parking area to the existing approach sidewalk just in front of these parking spaces. This "best practices" approach to the key accessible site arrival point would lessen the likelihood that slow moving disabled pedestrians who often have the lower profile of one seated in a chair and who are currently forced to travel in active traffic lanes behind parked cars might be hit by cars and injured.

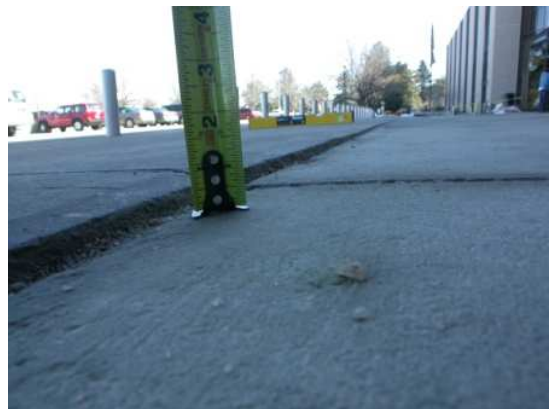
Figure 32 - Lip in Concrete at Main Entry Plaza

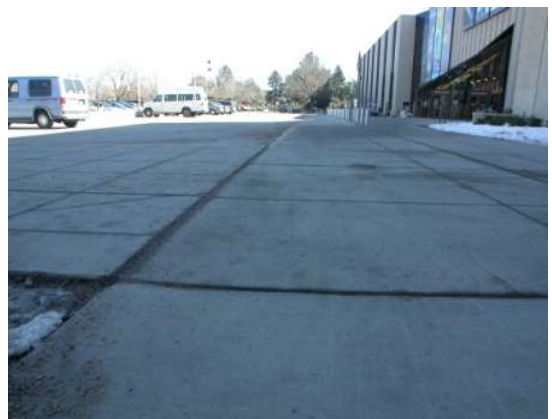
Figure 33 - Lip at End of Walk from Parking Garage

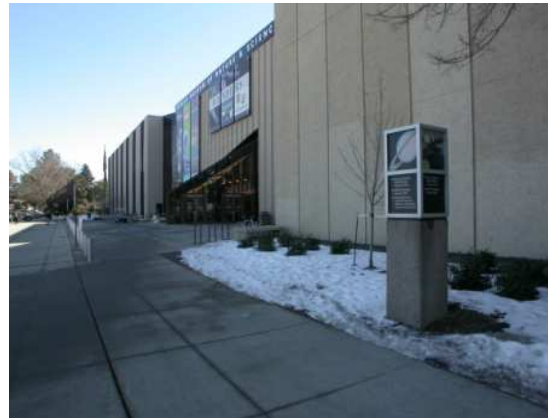
Figure 34 - Lip New Sign Kiosk near Main Entry

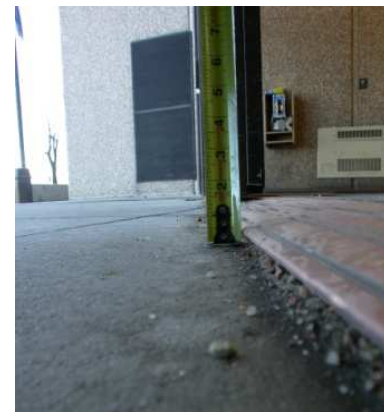
Figure 35 - High Threshold at the Eastern Most Main Entrance Doors

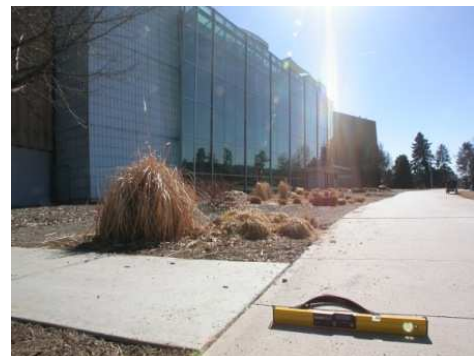
Figure 37 - Steep Cross Slope at Special Events Entrance Approach

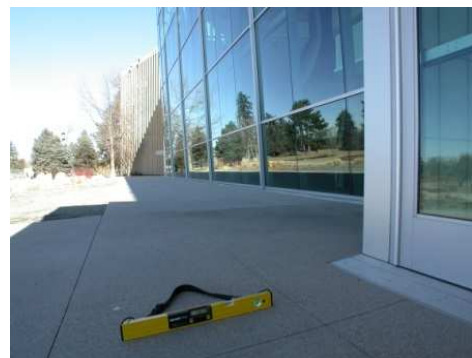
Figure 38 - Inaccessible Landing at the Automatic Doors of the Special Events Entrance (Steep 5.7% Cross Slope)

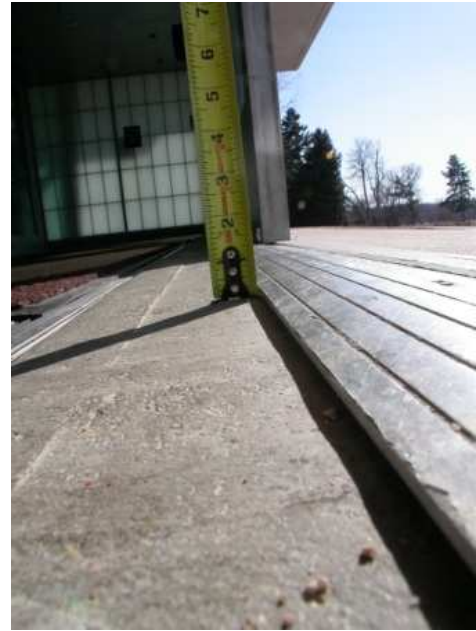
- f. At the exterior doors of this vestibule, one door (the northern most) has an automatic opener, but the interior side of the threshold is higher (at 3/4") than the maximum allowable 1/2" for such doors (UFAS 4.13.8). See Figure 39

Figure 39 - High Threshold at Special Event Entrance

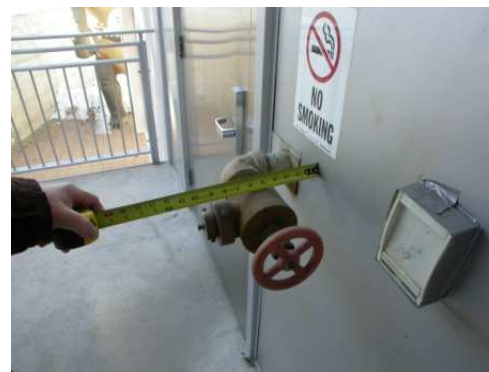
Figure 42 - Sprinkler Stand Pipes Protrude into Garage Approach Routes

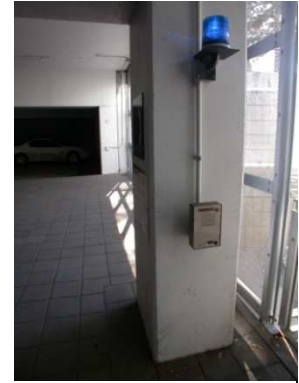
Figure 43 - Protruding Blue Lights

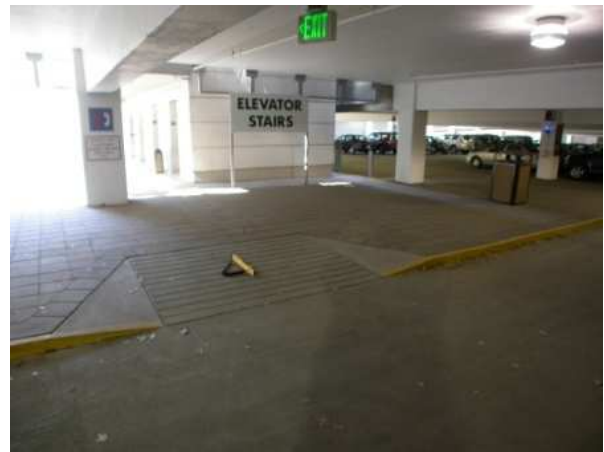
Figure 44 - Low Head Height at "Elevator/Stair" Sign in Parking Garage

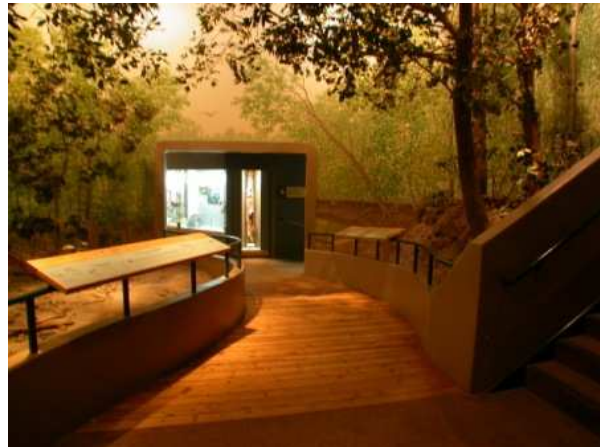
Figure 46 - Inaccessible Prehistoric Journey Ramp

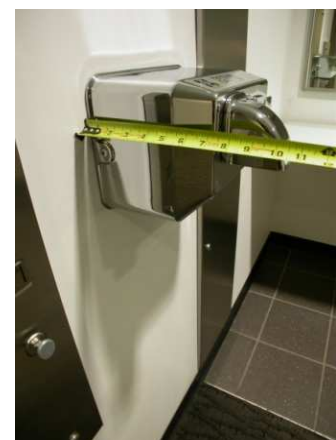
- a. **Semi-private Lounge Area.** The wall mounted hand dryers project more than 4" into the circulation route above 27" without cane detectable barriers provided (UFAS 4.4). A lounge chair is positioned so it blocks the minimum 48" wide door maneuvering space at Family Restroom C and must be relocated (UFAS 4.13.6). See Figure 47

Figure 47 - Typical Protruding Hand Dryer

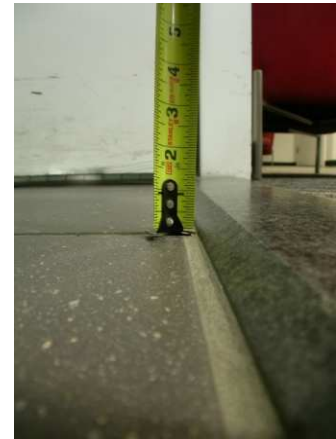
- d. **Family Restroom C.** The granite threshold at the entry door is 5/8" high with bevels on each side that are (at 1:1) steeper than the maximum allowable 1:2 bevel per UFAS 4.13.8. This non-fire rated entry door has a closer force (at 13 lbf) heavier than the maximum 5 lbf required by UFAS 4.13. 11(b). The wall mounted hand dryers project more than 4" into the circulation route above 27" without cane detectable barriers provided (UFAS 4.4).

Figure 48 - Inaccessible Threshold at Typical Family Restroom Doors

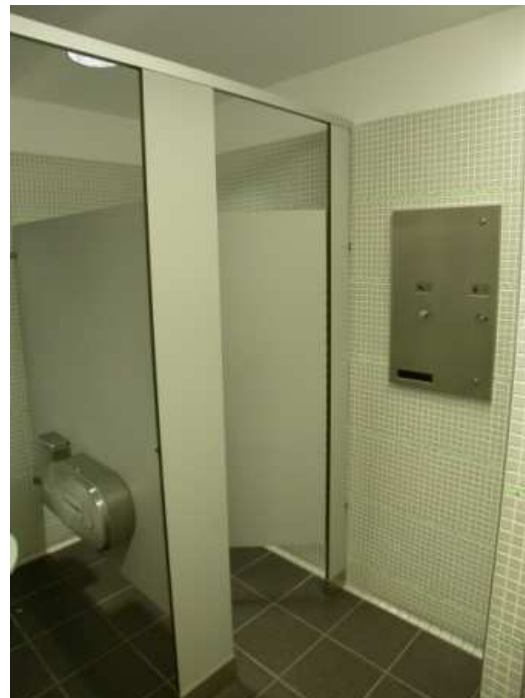
Figure 49 - Typical Inaccessible Feminine Napkin Dispenser

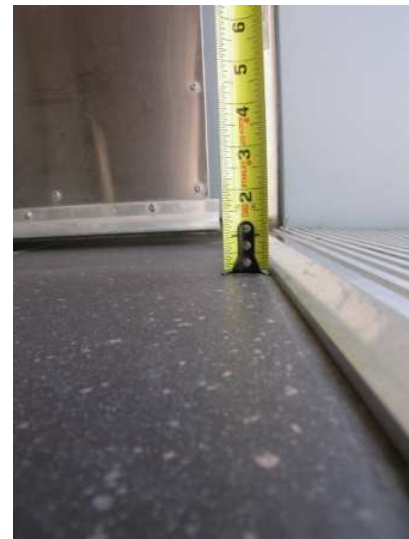
- b. Women's Restroom. The metal threshold at the entry door is 5/8" high with bevels on each side that are (at 1:1) steeper than the maximum allowable 1:2 bevel per UFAS 4.13.8 (See Figure 50). The wall mounted hand dryers project more than 4" into the circulation route above 27" without cane detectable barriers provided (UFAS 4.4). The feminine napkin dispensers have inaccessible round knob controls that are mounted higher than 54" (UFAS 4.22.7). The coat hook on the interior side of the entry door is mounted above the maximum 54" height (UFAS 4.25.3).

Figure 50 - Typical Inaccessible Metal Threshold Sky Terrace Restrooms

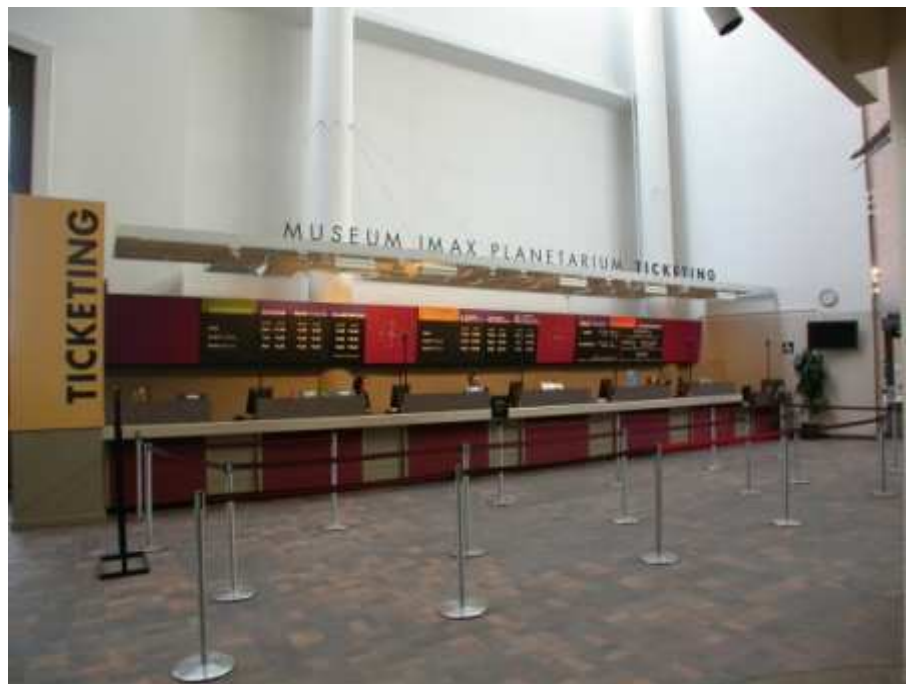
Each of these four counters has a portion that is lowered for wheelchair use, but those lowered portions also create protruding objects that could be hazardous to blind and visually impaired visitors because of the lack of cane detectable barriers (UFAS 4.4). This is also true for the brochure storage element on the Information counter and the wall hung TV to the right of the main ticket counter which does not provide a minimum 80" head height along the circulation route. The queuing areas at the

Figure 52 - Main Ticket Counter with Protruding TV at Right Side of Image
