SECTION 504 COMPLIANCE REVIEW REPORT

Denver Museum of Nature and Science

Denver, Colorado

March 2011

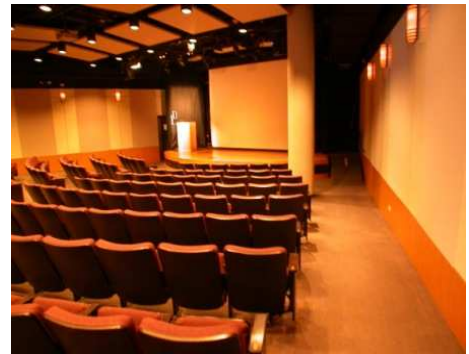
Figure 14 - Ricketson Auditorium

Level 1 - Ricketson Auditorium. This appears to be an older area of the facility. In this 250 seat auditorium, none of the 7 required wheelchair seating spaces are provided and a sloping floor (5%-6.6%) without any level seating areas integral with the fixed seats will make modifications more challenging (UFAS 4.1.2(18)). Assistive listening systems are provided. The route to the stage includes a very steep (30.2%) ramp that is dangerous for wheelchair use and must be replaced (UFAS 4.5.2). See Figure 14

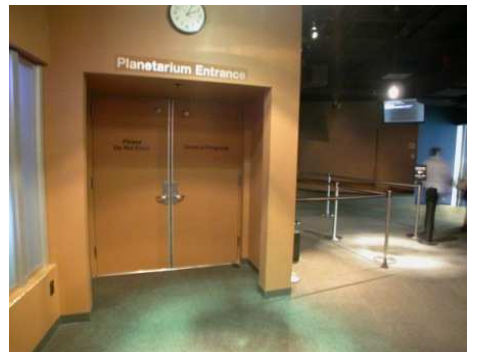
Figure 15 - Planetarium Entrance

Level 1 - Charles C. Gates Planetarium. This appears to be an older area of the facility. There is space at the back row of this planetarium for 5 wheelchairs, which is compliant with the number required for an assembly space such as this with approximately 150 seats (See Figure 15). Assistive listening systems and rear-view

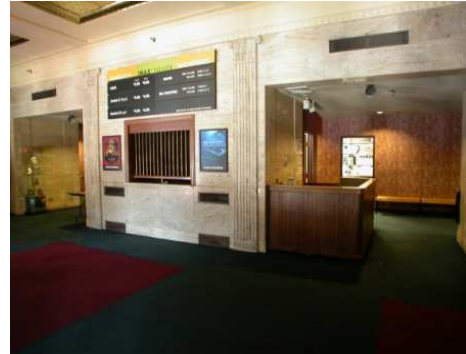
Figure 21 - Historic IMAX Box Office

Level 2 - Phipps IMAX Theater. This appears to be an older area of the facility and depending on when the IMAX show is scheduled to begin, there are two approaches to the theater. If the show is during regular business hours of DMNS, then those who cannot use stairs are asked to go to an accessible Level 3 waiting area, from which an usher will escort the visitor(s) to the wheelchair seating areas on the upper level of the auditorium. If the show starts after regular business hours for the Museum, there is an "after-hours" entrance on the east side of the exterior of the building and accessible parking serves this entrance. The designated accessible "after-hours" entrance is to the right of the main "after-hours" entrance and leads to an elevator lobby from which a disabled visitor can proceed to the box office level to purchase tickets and have an usher escort the visitor(s) to the wheelchair seating areas on the upper level of the auditorium. This elevator also serves the designated accessible restrooms below the box office level. DMNS must ensure that an usher is available whenever a wheelchair user needs to get to their seat and restroom. While the box office ticket counter is higher than 36", it is acceptable as an historic element and because alternate programmatic accommodations may be provided as needed for wheelchair users. See Figure 21

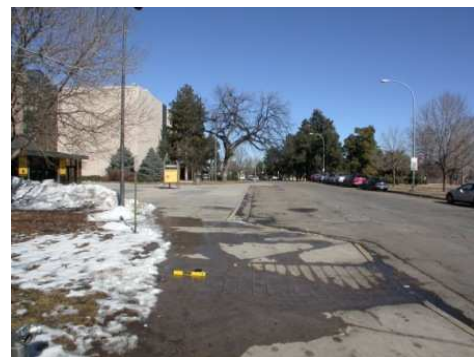
Figure 36 - "After-Hours" IMAX Parking & Approach Route

- d. While the walkway and curb ramp leading from the bus shelter area to the driveway in front of the "After-Hours" Entrance to the IMAX is substantially compliant with UFAS, the City should reconstruct the curb ramp on the west side of this driveway because there is no level (at 2.9%) by-pass space or top landing at this curb ramp (UFAS 4.3.7); See Figure 36

1. The asphalt surface at the designated accessible parking space serving the "After-Hours" IMAX entrance is cracked and the striping deteriorated creating gaps greater than the 1/2" maximum specified in UFAS 4.3 - this area should be patched, sealed and restriped. See Figure 36
2. The painted striping for the designated accessible parking spaces directly in front of the main entrance (over the parking deck) has deteriorated and is hard to see (UFAS 4.6).
3. Two of the 11 designated accessible parking spaces on the east side of the main entrance parking area lack post mounted signs that cannot be obstructed when a vehicle is parked in the space (UFAS 4.6.4). See Figure 41
4. Four of the 13 designated accessible parking spaces directly in front of the main entrance (over the parking deck) lack post mounted signs that cannot be obstructed when a vehicle is parked in the space (UFAS 4.6.4).

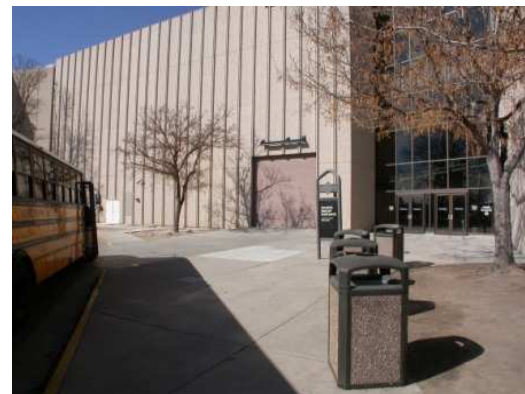
Figure 40 - School Group Loading Zone & Student Entrance Area

4. **School Group Entrance (South Side)** - This entrance approach is generally compliant with UFAS, but a sign and/or surface markings on the pavement should be provided for bus drivers designating the area at which wheelchair lifts on the buses should be deployed. This designated area must be located at the curb directly in front of the entry doors because this area has accessible surface slopes and is on an accessible route to the entry doors. If the school buses deploy their lifts further around the circular driveway, they will force wheelchair visitors to negotiate an inaccessible (4.4%) cross slope created by the intersection of the loading dock driveway and the sidewalk running along the circular drive (UFAS 4.3.7). The door with the automatic opener was malfunctioning at the time of our survey (only opening 25"

wide) and needs to be adjusted so it will open the door fully 90 degrees for the required minimum 32" clear passage width (UFAS 4.13.5). See Figure 40.

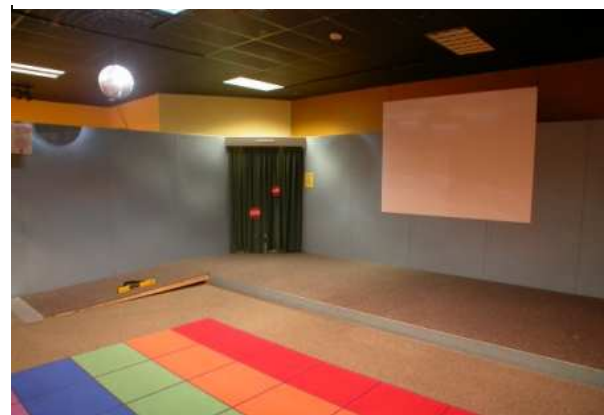
Figure 45 - Discovery Zone Ramp & Stage

3. **South Ramp in IMAX Auditorium.** This wheelchair seating area is accessed via a short ramp that lacks edge protection on the open side and also lacks an accessible handrail on the wall side of the ramp (UFAS 4.8.7; 4.8.5).
4. **Level 2 - Discovery Zone Demo Stage.** This raised stage is accessed by a carpet covered plywood ramp which lacks edge protection on the open side (UFAS 4.8.7). See Figure 45
5. **Level 3 - Prehistoric Journey.** The ramp leading away from the lower level exit door from the second enclosed platform lift slopes (at 6.1%-9.1%) more than 5% and lacks required accessible handrails (UFAS 4.8.5). See Figure 46

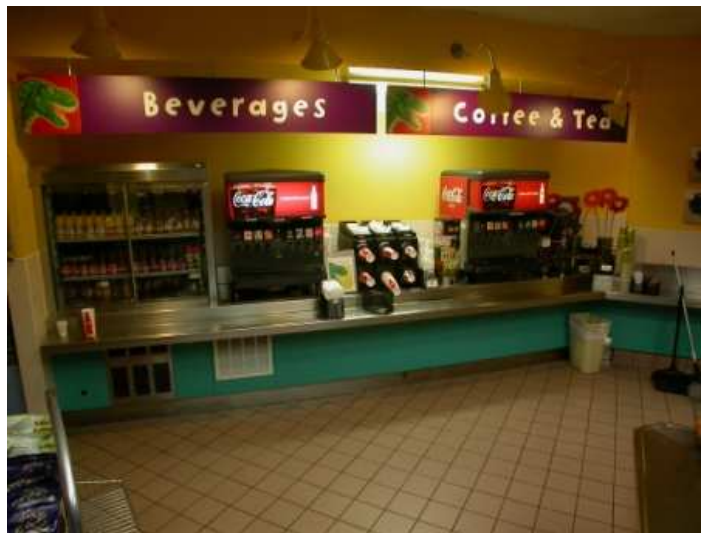
Figure 51 - T-Rex Cafe Drink Dispensers & Lids

1. The lids for the soda cups are located above (at 54" high 24" back) the maximum 46" height for side wheelchair reach range over and obstruction (tray slide) per UFAS 5.3). See Figure 51
